NACA RM E9F16

EXPERIMENTAL INVESTIGATION OF RIM CRACKING IN DISKS
SUBJECTED TO HIGH TEMPERATURE GRADIENTS

By P. I. Wilterdink

WASHINGTON
September 1, 1949

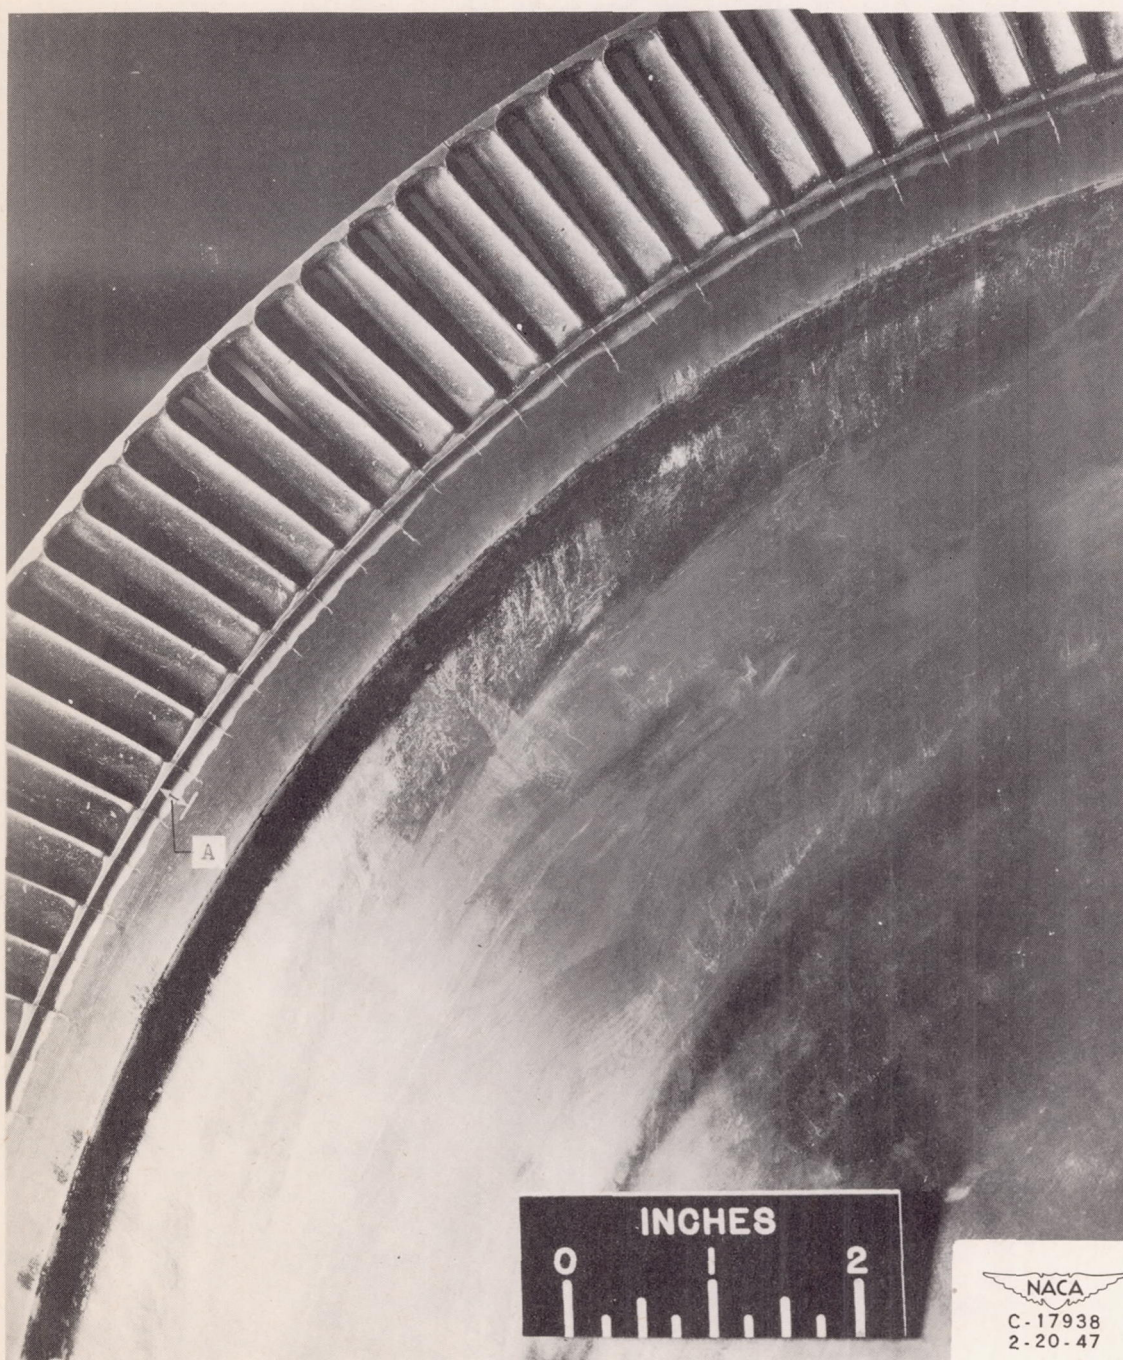
Turbine wheel and modifications. - The investigation was conducted on a composite-type gas-turbine wheel. The center was SAE 4340 steel. The $2\frac{1}{4}$ -inch radial-thickness rim, which was welded to the center part of the wheel, was Timken 16-25-6. The blades were welded to the rim. The turbine wheel was one that had been operated in a turbine-propeller engine until cracks between the blades had progressed some distance into the rim. A photograph of part of the wheel at the time it was removed from service is presented in figure 1. The length of the cracks, dimension A (fig. 1), was measured from the edge of the bevel on the rim at the base of the blades. At the time the wheel was removed from service, the average length of all cracks was 0.22 inch.

Figure 1. - Turbine wheel at time it was removed from turbine-propeller engine.

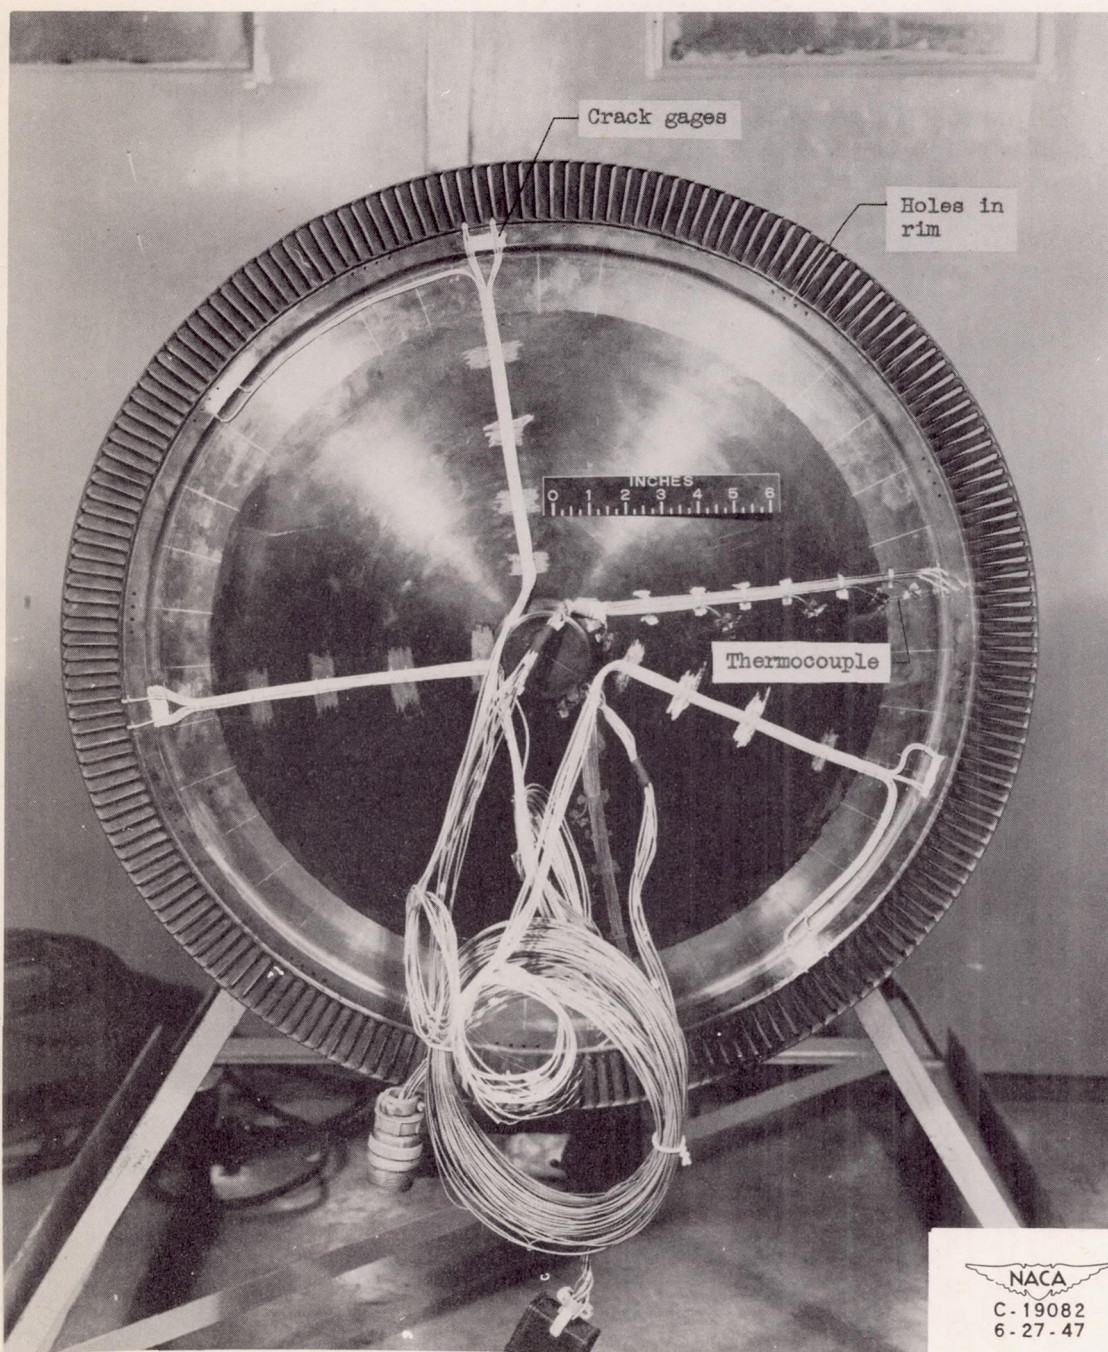
The downstream side of the wheel, after holes were drilled in groups of four, with an average spacing of 12 blades between each group of holes is shown in figure 2. Table I gives the locations and the hole sizes. The holes were drilled on the radial line between the bases of two adjacent blades, as shown in figure 3. The distance, B (fig. 3), from the center of the holes to the bevel

Figure 2. - Holes, thermocouples, and crack gages on downstream side of gas-turbine wheel.

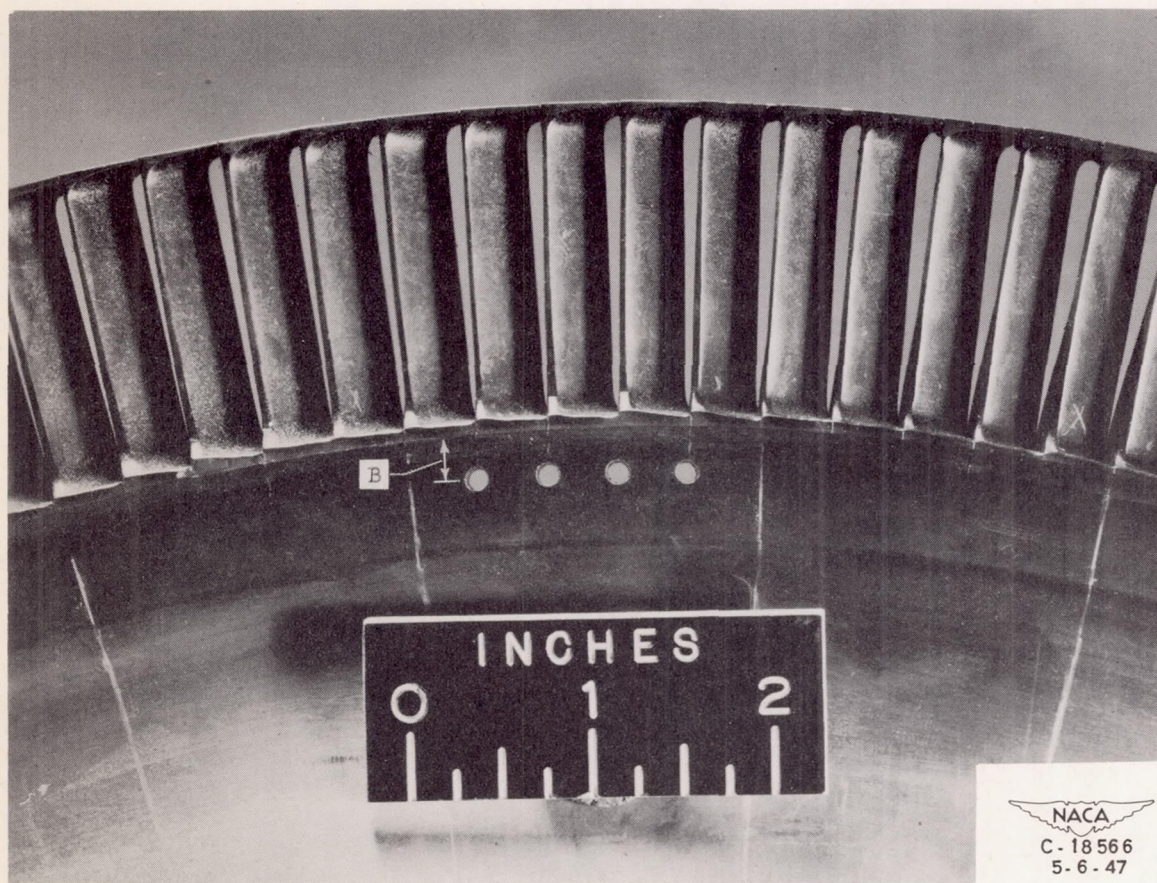
on the rim at the base of the blades varied from $3/16$ inch to $5/16$ inch as shown in table I. This distance was constant for each group of four holes. Holes were drilled at the base of approximately 25 percent of the blades. Six groups of four holes each or a total of 24 holes were $1/16$ inch in diameter and six groups of four holes each were $1/8$ inch in diameter.

Figure 3. - Hole locations in gas-turbine wheel rim.

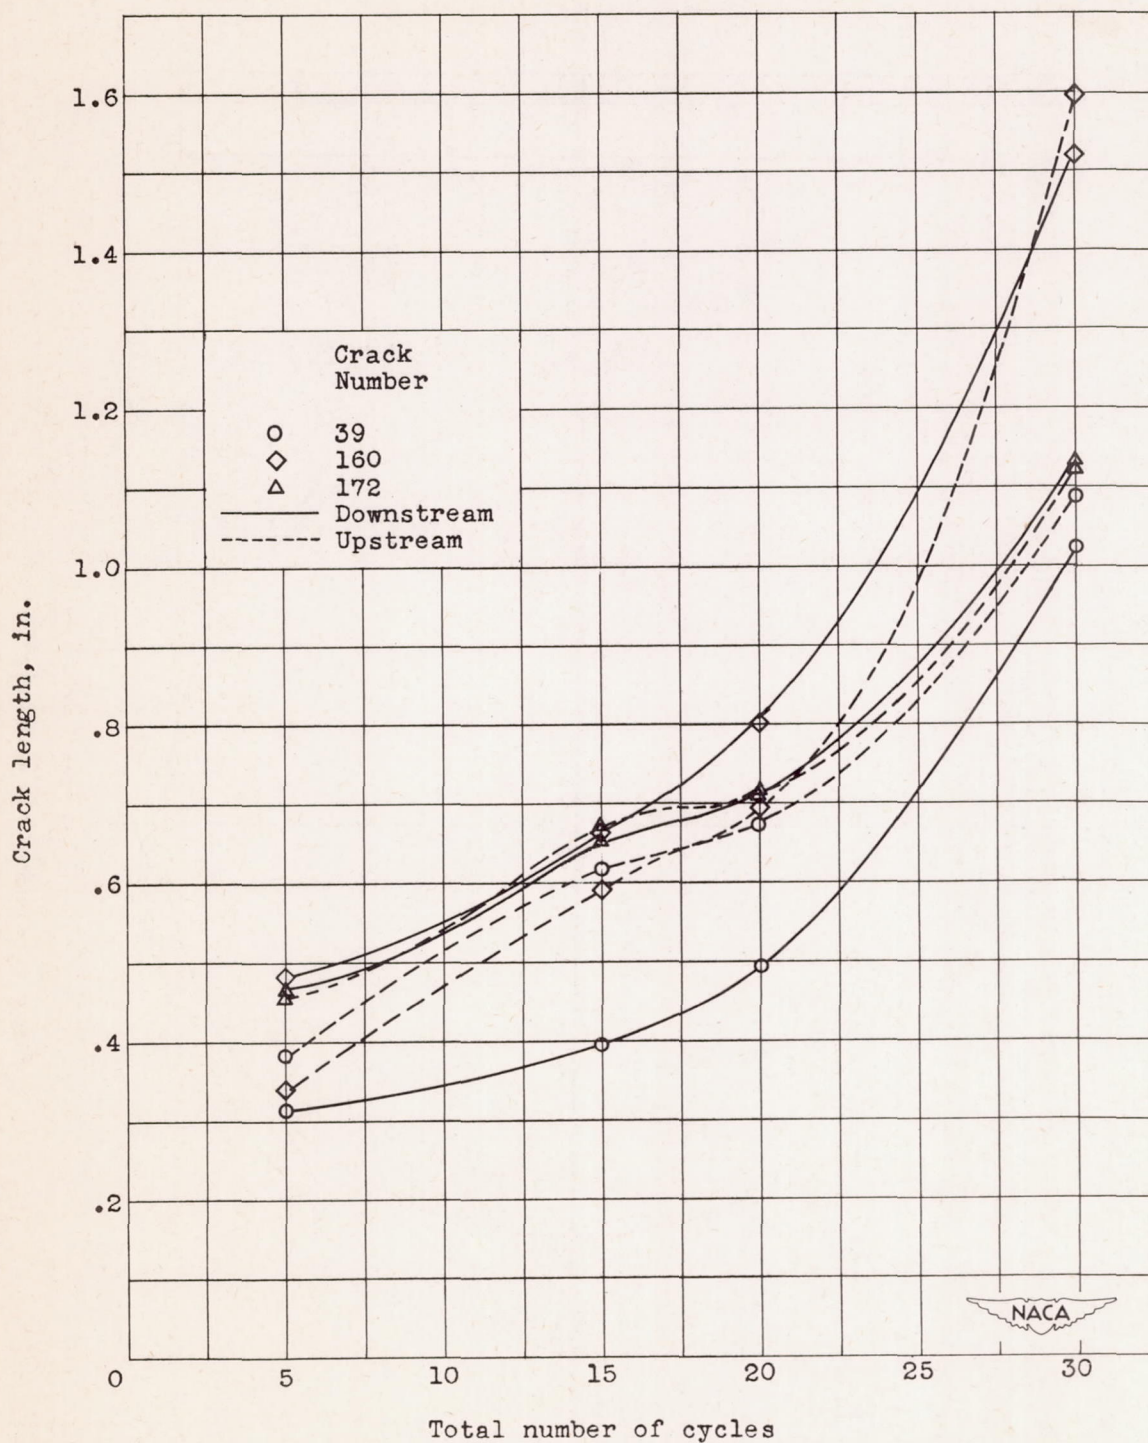
Rate of crack growth. - The results of the measurements of crack length are presented in table III. The cracks shorter than 0.22 inch seem to have grown very little or none during the runs. One reason for the apparent negative growth of the short cracks was that when the length of a crack exceeded 0.22 inch, it was not reported in this group. The omission of the longer cracks may decrease the average crack length for the remaining cracks in the group. The inaccuracies in crack measurements may also have contributed to the apparent negative growth. In general, the long cracks grew much more rapidly than the short cracks. The manner in which the long cracks grew is shown in figure 7. The rate of growth for the long cracks increased as the length of the cracks increased. This increase seemed to indicate that as the testing progressed the portion of stress relief occurring in the long cracks became larger.

Figure 7. - Growth of long cracks in gas-turbine wheel.

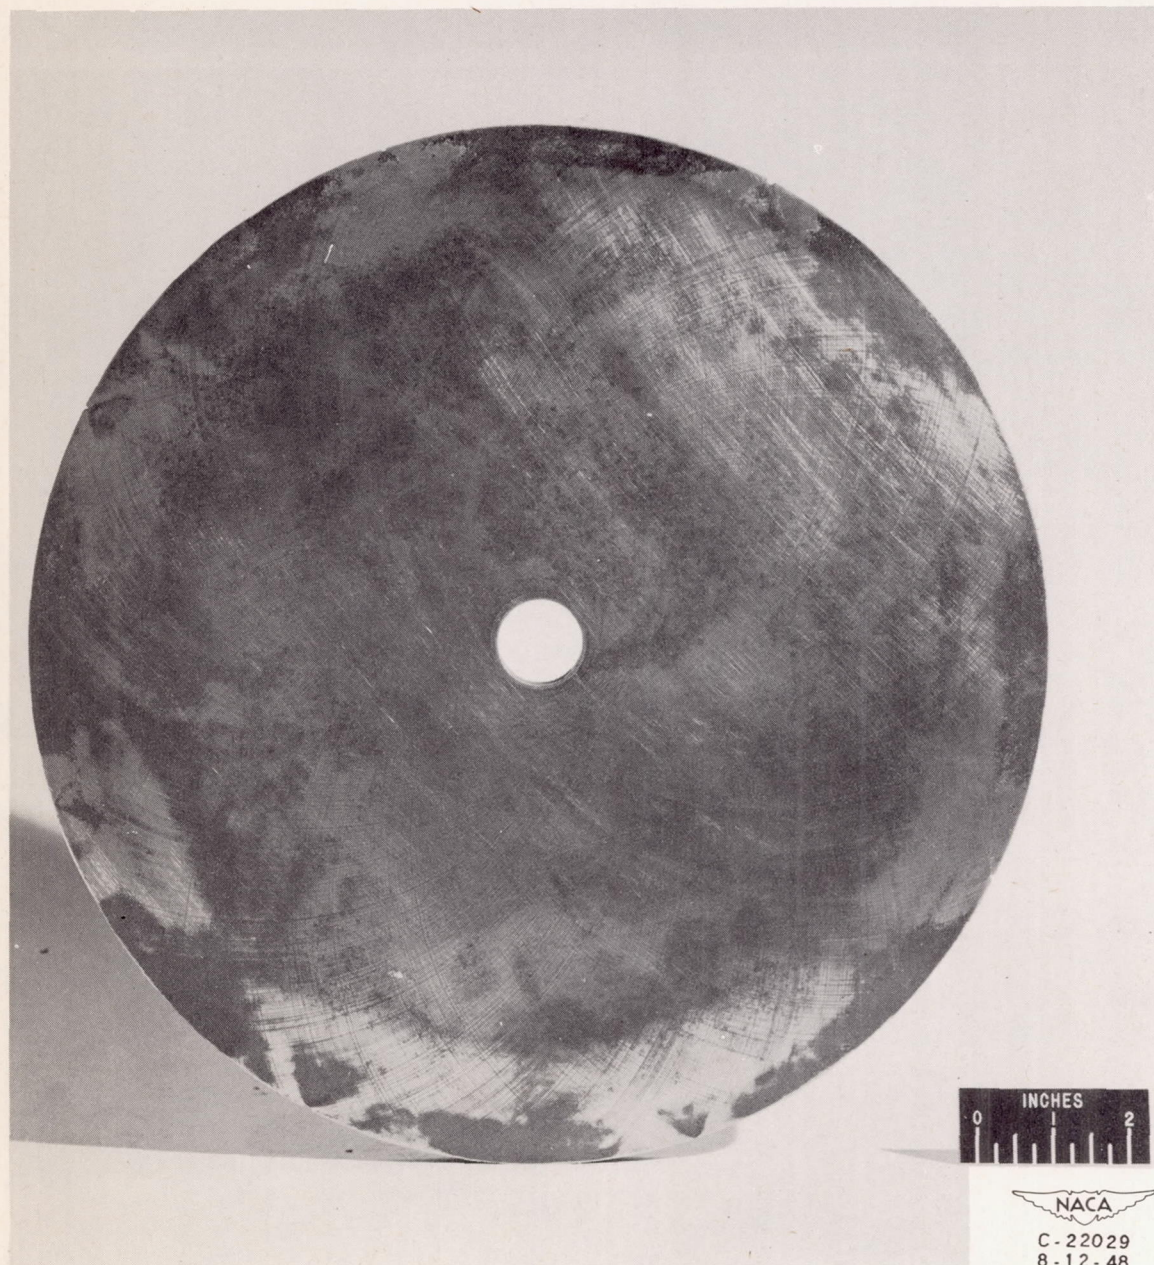
It was impossible to produce cracking at the notches in the rim under the previously described conditions. The flat disk was subjected to approximately 200 thermal-stress cycles and the tapered disk was subjected to approximately 20 cycles in which the maximum rim temperature was 1350° F. The conditions of the disks after the runs are shown in figures 12 and 13. The dark areas at the bottoms of the notches were brought out by removing the scale with a piece of emery cloth, which was supported by a flat piece of steel. These areas were depressions somewhat below the surface of the disks. The center parts were the regions of greatest depression in the dark areas. The areas at the bottoms of the notches resembled plastic-flow figures or Lüders' lines.

Hardness surveys taken after the runs were completed showed that the hardness at the edge of the rim was approximately Rockwell C-10. On the tapered disk, which had been subjected to only 20 thermal-stress cycles at 1350° F, the reduction in hardness started approximately $1\frac{1}{2}$ inches from the edge of the disk. In the case of a flat disk, which had been subjected to approximately 200 cycles at 1350° F, the reduction in hardness started approximately 3 inches from the edge of the disk. After a few cycles of heating, the rims of the disks lost their hardness and plastic flow occurred at the bottom of the notches. A possible factor contributing to the absence of cracking was that the maximum temperature of 1350° F at the rim was high enough to allow a considerable amount of stress relief in carbon steel during the time at which the rim was at that temperature.

Figure 12. - Condition of SAE 1045 13.5-inch-diameter disk after runs.

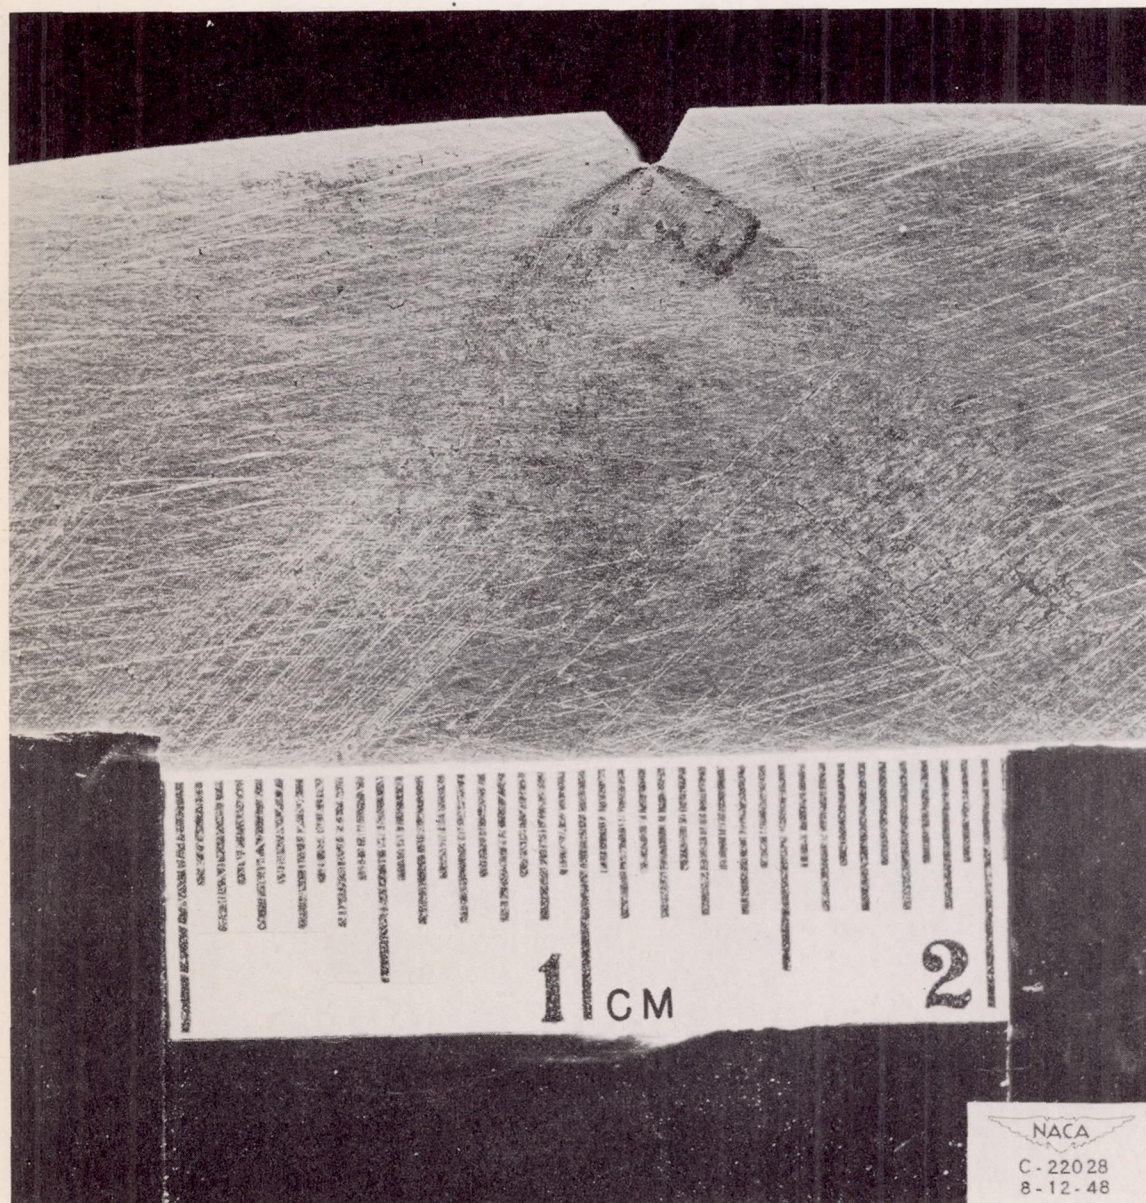
Figure 13. - Plastic flow at notch in SAE 1045 13.5-inch-diameter disk.

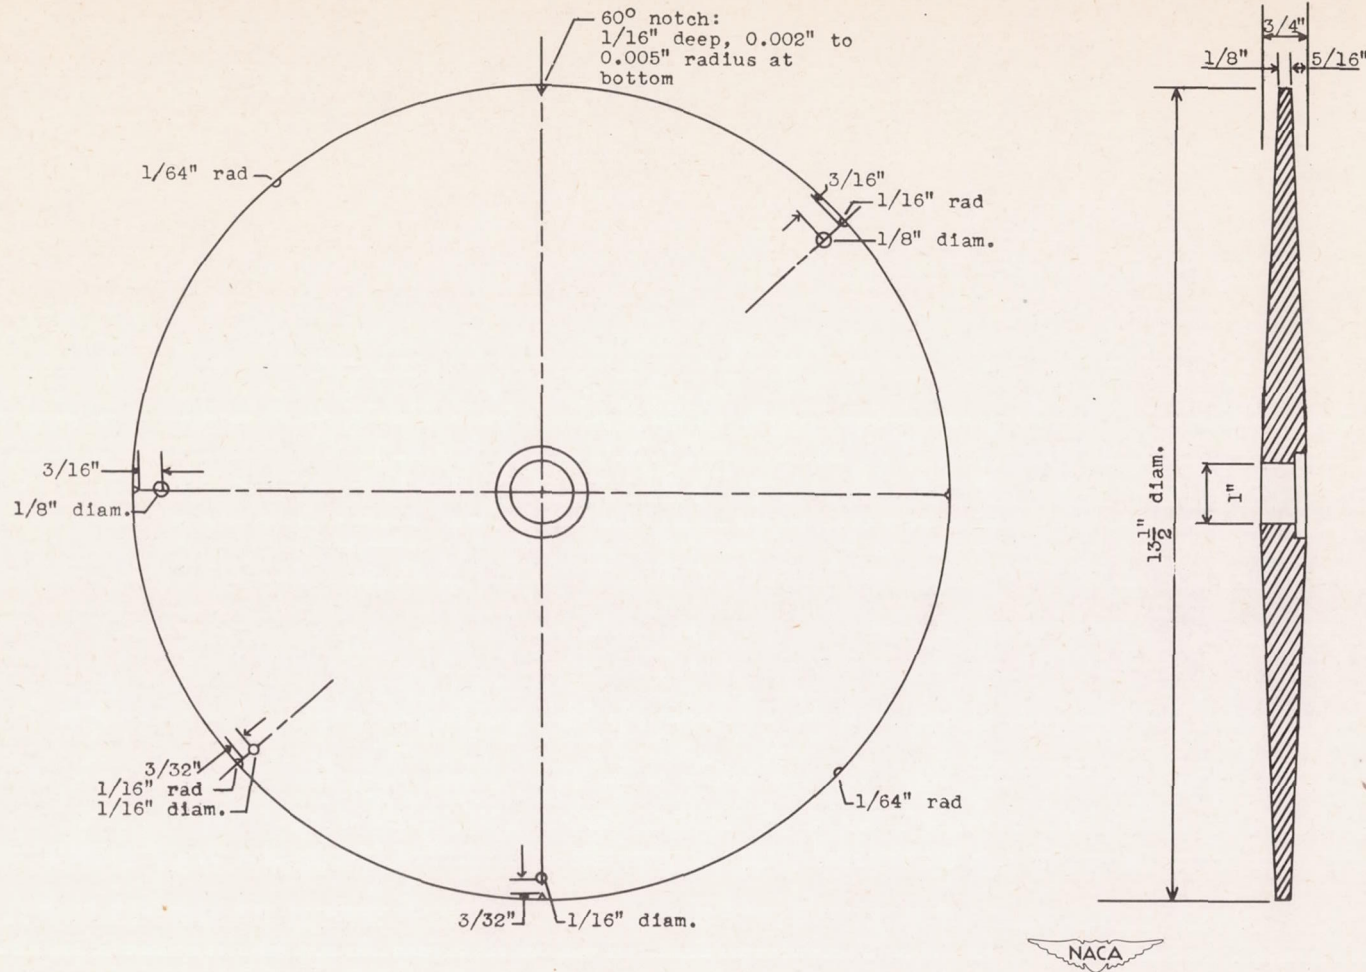
Occurrence of cracks. - With one exception, the first crack occurred between the 60°-V notch and the 1/16-inch-diameter hole. The relation between the holes and the notches is shown in figure 14. In most cases, within a few cycles after the first crack occurred and at the same temperature gradient, cracks occurred at the remaining V notches irrespective of the presence of holes. With two exceptions, no cracks occurred between the semicircular notches and the holes. In the case of the V notches without holes, the cracks generally grew about 1 inch during the cycle in which they occurred. This initial growth seemed to occur in a very short time or instantaneously. During the cycle at which the crack passed through the hole, the crack length increased about 1/4 inch. The crack lengths increased very slowly after the cycle during which they occurred. The preceding statements about rates of crack growth apply to all of the disks except the one with low hardness (Rockwell C-11). The cracks in the low-hardness disk progressed

Figure 14. - Notched- and drilled-rim 13.5-inch-diameter tapered tool-steel disk.

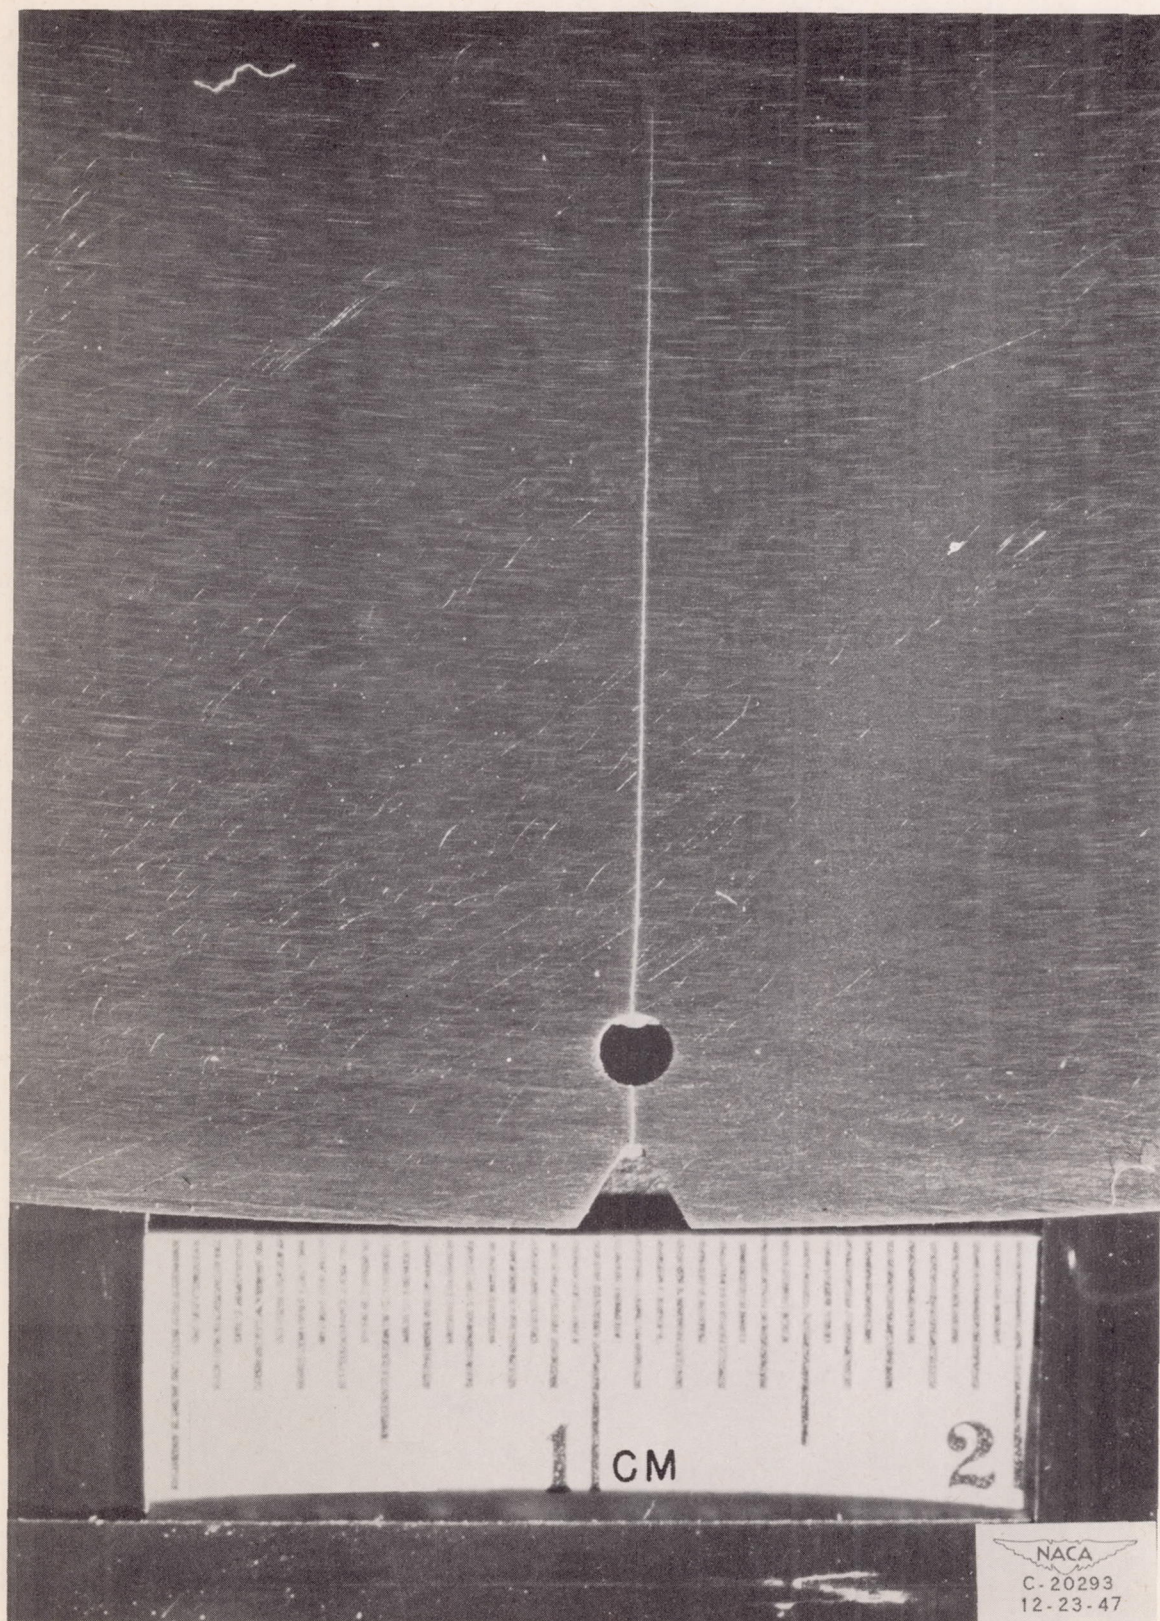
only a very short distance during the cycle in which they occurred. The appearance of cracks in the hard disks is shown in figure 15. A typical crack in the disk with low hardness is shown in figure 16.

Figure 15. - Radial crack in 13.5-inch-diameter tool-steel disk. Hardness, Rockwell C-60.

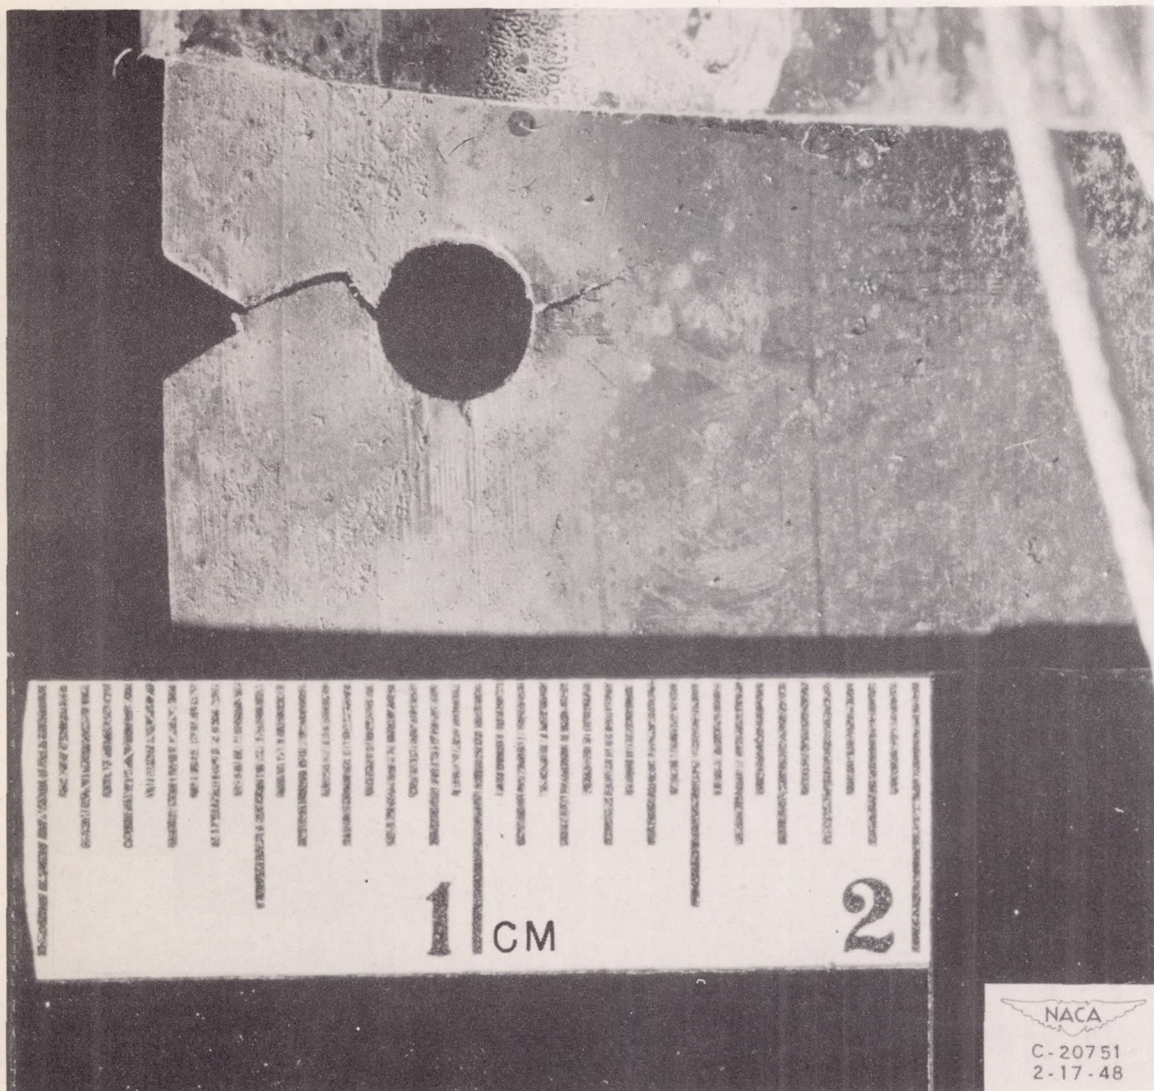
Figure 16. - Crack in 13.5-inch-diameter tool-steel disk. Hardness, Rockwell C-11.

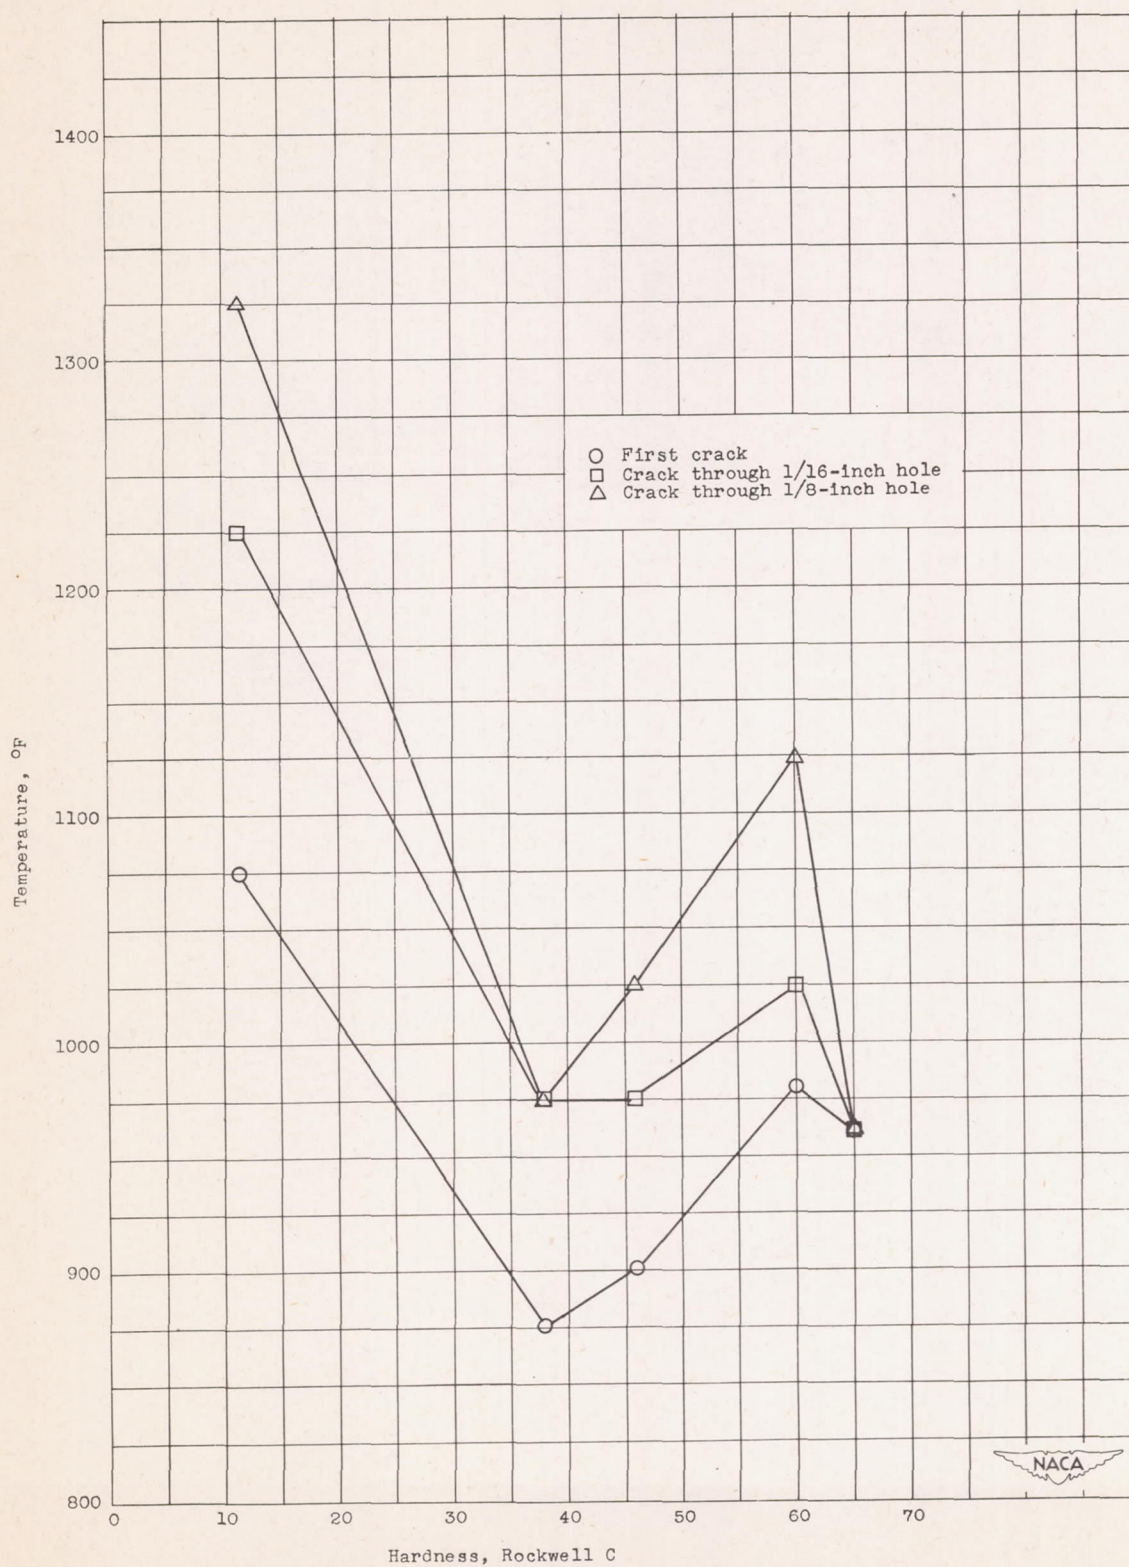
Effectiveness of holes. - The temperatures at which first cases of the several cracking phenomena occurred in the various disks are shown in figure 17. One point on each of the three curves was obtained from each disk. The hardness of the disks is indicated by the abscissa. The increase in temperature, above that producing cracks, required to cause the crack to progress through a 1/16-inch hole indicates the effectiveness of such a hole in preventing crack growth. The same statement may be made for the 1/8-inch holes, which were more effective than the 1/16-inch-diameter holes in preventing crack growth.

Influence of hardness and other factors on rim cracking. - The disks of materials with Rockwell C hardnesses of 38 and 46 had low cracking temperatures as shown in figure 17. For this range of hardness, according to references 3 and 4, tool steels of this type have low toughness and impact strength. The toughness and the impact strength are higher for disks that are harder or softer than those disks in the Rockwell C hardness range from 38 to 46. The loss of toughness or impact strength seems to have been the significant factor in causing the low cracking temperatures for disks with Rockwell C hardnesses of 38 and 46. In general, from figure 17, reducing the hardness of the disk evidently increases resistance to cracking.

Figure 17. - Cracking temperatures in 13.5-inch-diameter tool-steel disks.
